THE HIPEG SYSTEM (20mm Aircraft Gun Mk 11 and Gun Pod EX 1) Progress Report for May 1962

HUGHES TOOL COMPANY · AIRCRAFT DIVISION Culver City. California

#### Report HTC-62-39

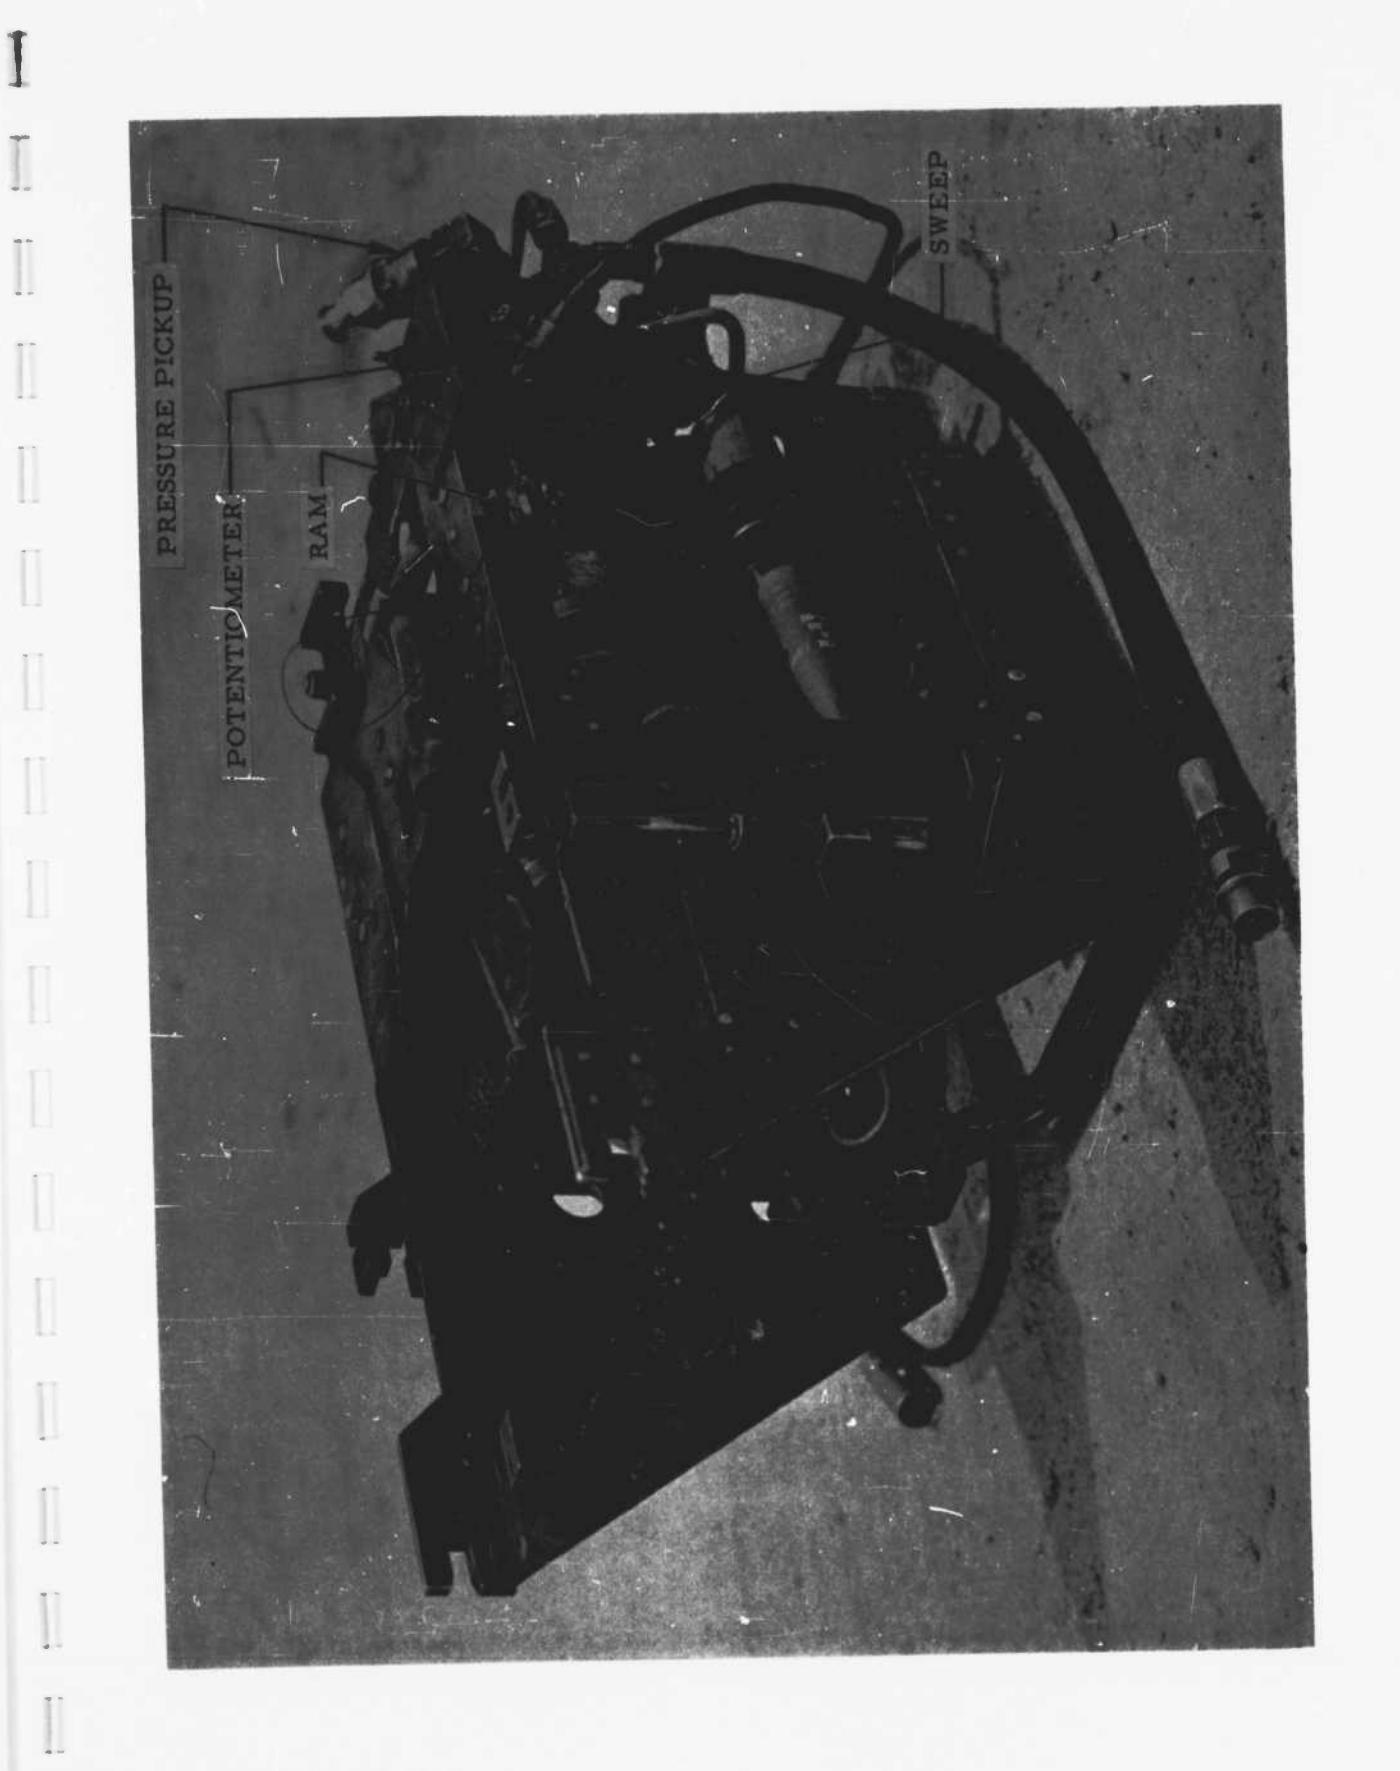
Figure 2. Instrumentation Used in Reliability Test of Gun Pod

As stated above, primary emphasis has been placed on the ram problem and establishing a means to its solution. As a first step the rams were instrumented so that time displacement traces could be recorded together with ram pressure and the other instrumentation normally taken (recoil and firing voltages). The same type of potentiometer used in recoil time displacement recordings was mounted on the loader as shown in Figure 1. The pot-sweep was attached to the ram and the traces of Figure 2 were recorded. Initial instrumentation life was short because of the 4000 G's applied to it. As a result the instrumentation was not always recording properly by the time failures were encountered. The sweep-pod configuration is being improved for the application.

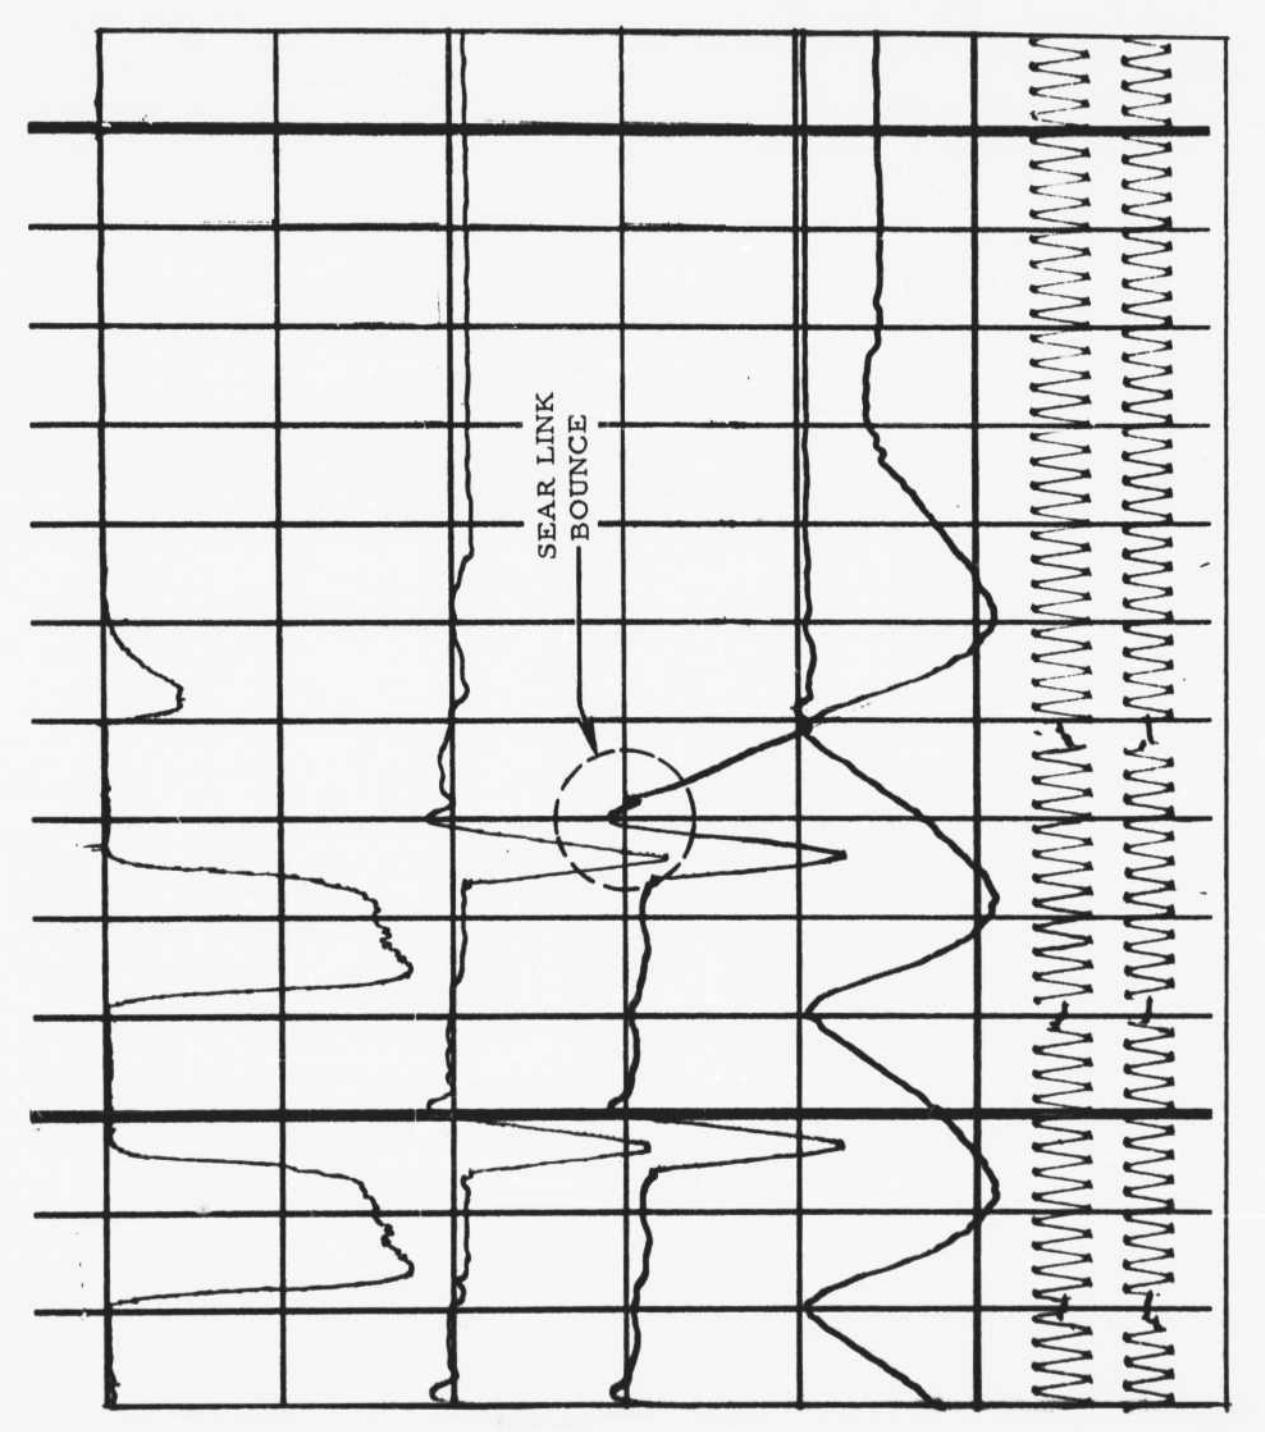
Figure 3. Oscillogram Showing Sear-Link Bounce

One recording was made (Figure 3) that shows that the sear link bounced out of engagement. The sear did have a mouse-trap spring which shows that the spring was inadequate and was not preventing sear link bounce. A sear latch is being tested on the R & D gun that will prevent sear bounce by latch action. The latch operates in the following manner: As the sear link cams over the sear, the sear link rotates the latch out of the way. When the sear link moves into the sear position, the latch rotates and positions itself under the link. An over-center lock is established by this latch and the sear link cannot bounce out of engagement.

Of the 16 loader stoppages recorded, 12 had to do with ramming. Ten of these were failures to resear and two were failures to ram deep enough. As stated earlier, the resear problem is being attacked with more instrumentation. Part of the problem has now been definitely proved as being caused by sear link bounce. Some of the failures to resear may also be caused by rammer contamination, which in '1rn would result in energy loss. It appears that the sear link bounce can be corrected by the rammer latch now under test.

and to establish if causes other than sear link bounce may be contributing. In the interim, latch hardware will be made for the Reliability Test guns.

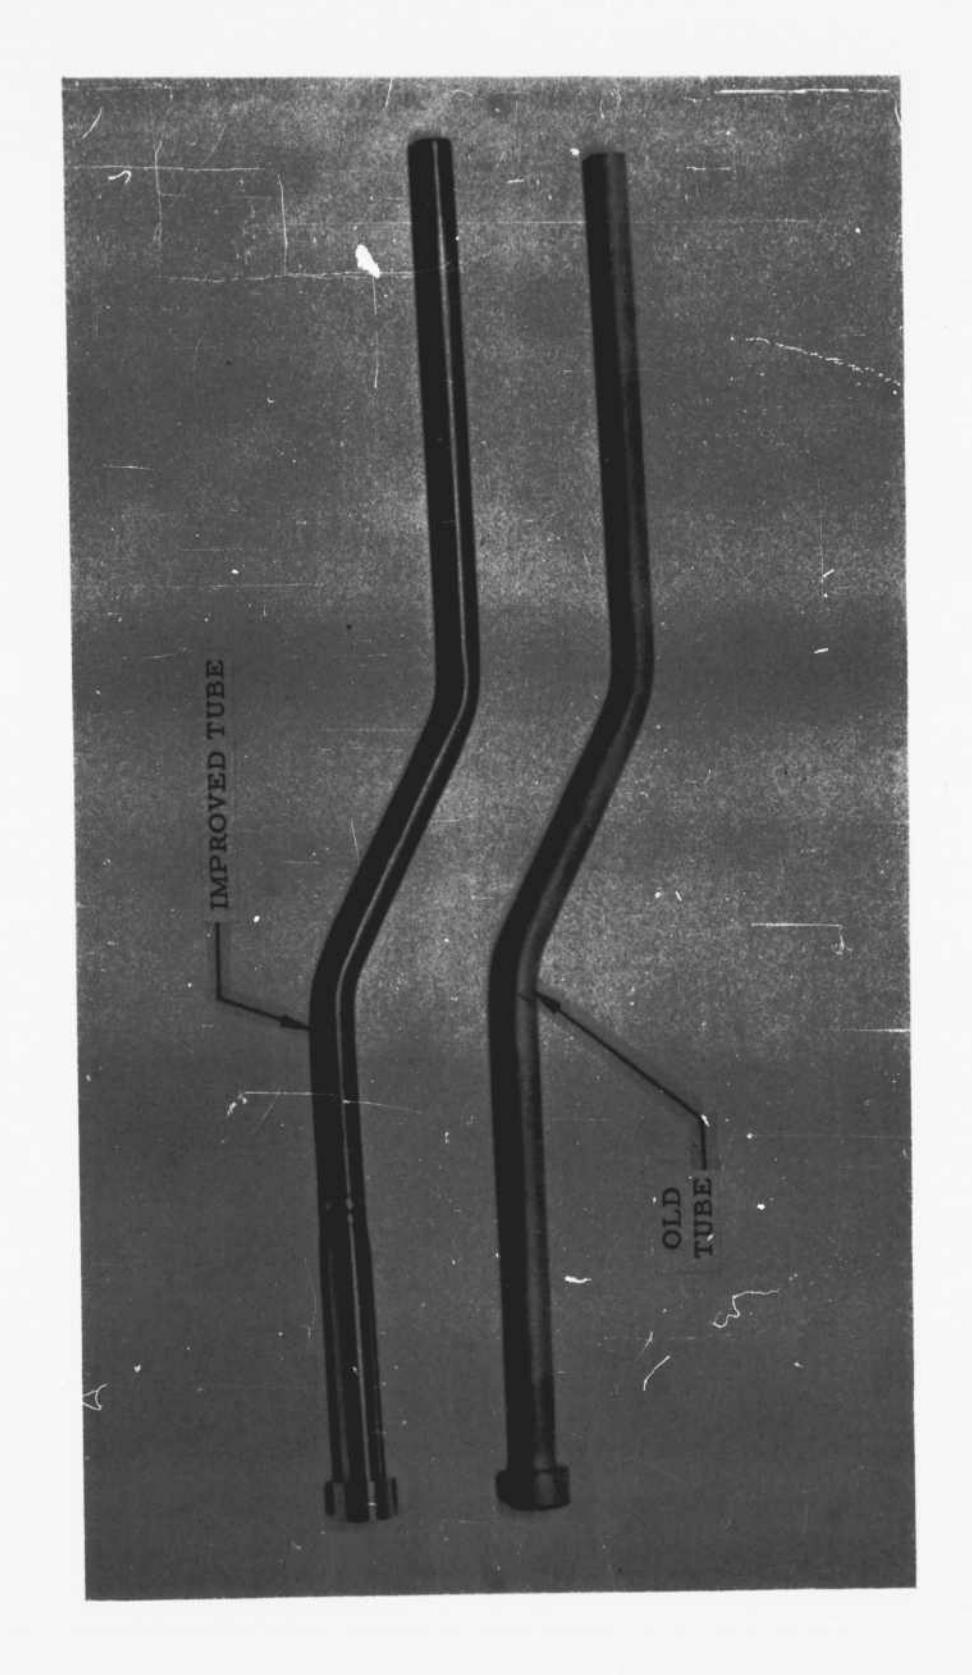
Figure 4. Ejection Gas Tube Redesign

One stoppage was the result of a broken gas ejection tube. The flange at the upstream end of the tube parted from the basic tube. The part was redesigned and the new and old parts are compared in Figure 4. The flange was made stronger and the welded joint moved downstream.
