Report No. HTC-AD 64-10

Final Report

20MM MARK 4 GUN POD
250,000 ROUND RELIABILITY IMPROVEMENT
PROGRAM

2 February 1964

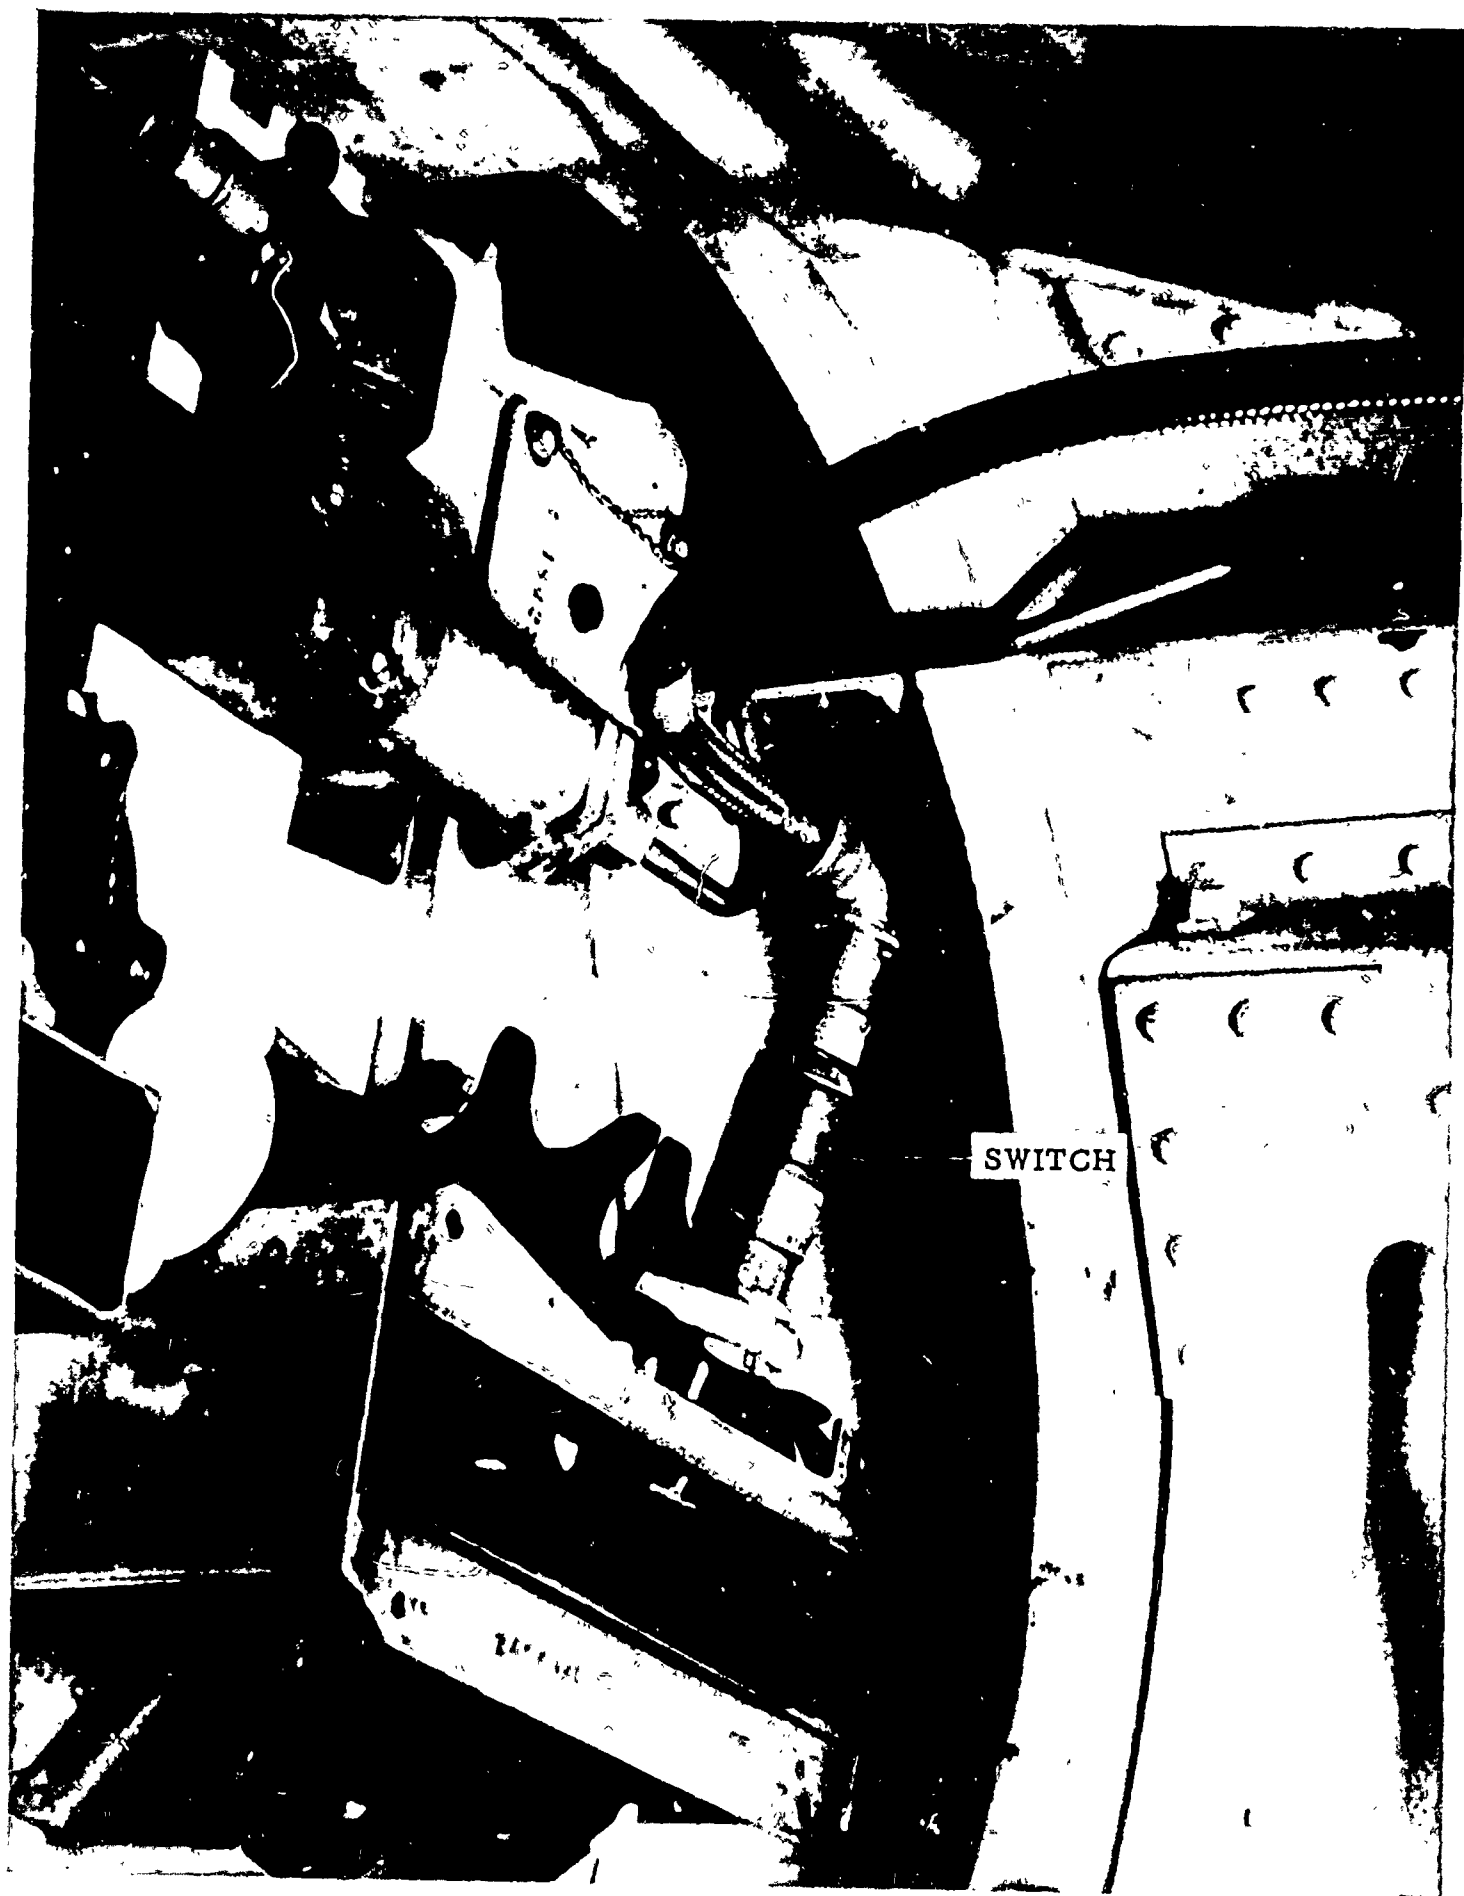
Figure 13. Last Round Switch

A switch was mounted on the ammunition drive sprocket to shut off the air motor. This switch opened when the last round in the magazine passed through, thus cutting the current to the air motor solenoid. Without this switch, the air motor would reach high rotational velocities and cause unnecessary wear. The last round switch is shown mounted in Figure 13. This switch may also be used to open the automatic charge circuit so that continuous charging would not take place after a fireout with a multiple pod installation. No problems were encountered using this switch, and the wear on the air motor was not noticeable at an inspection at 82,000 rounds of firing.

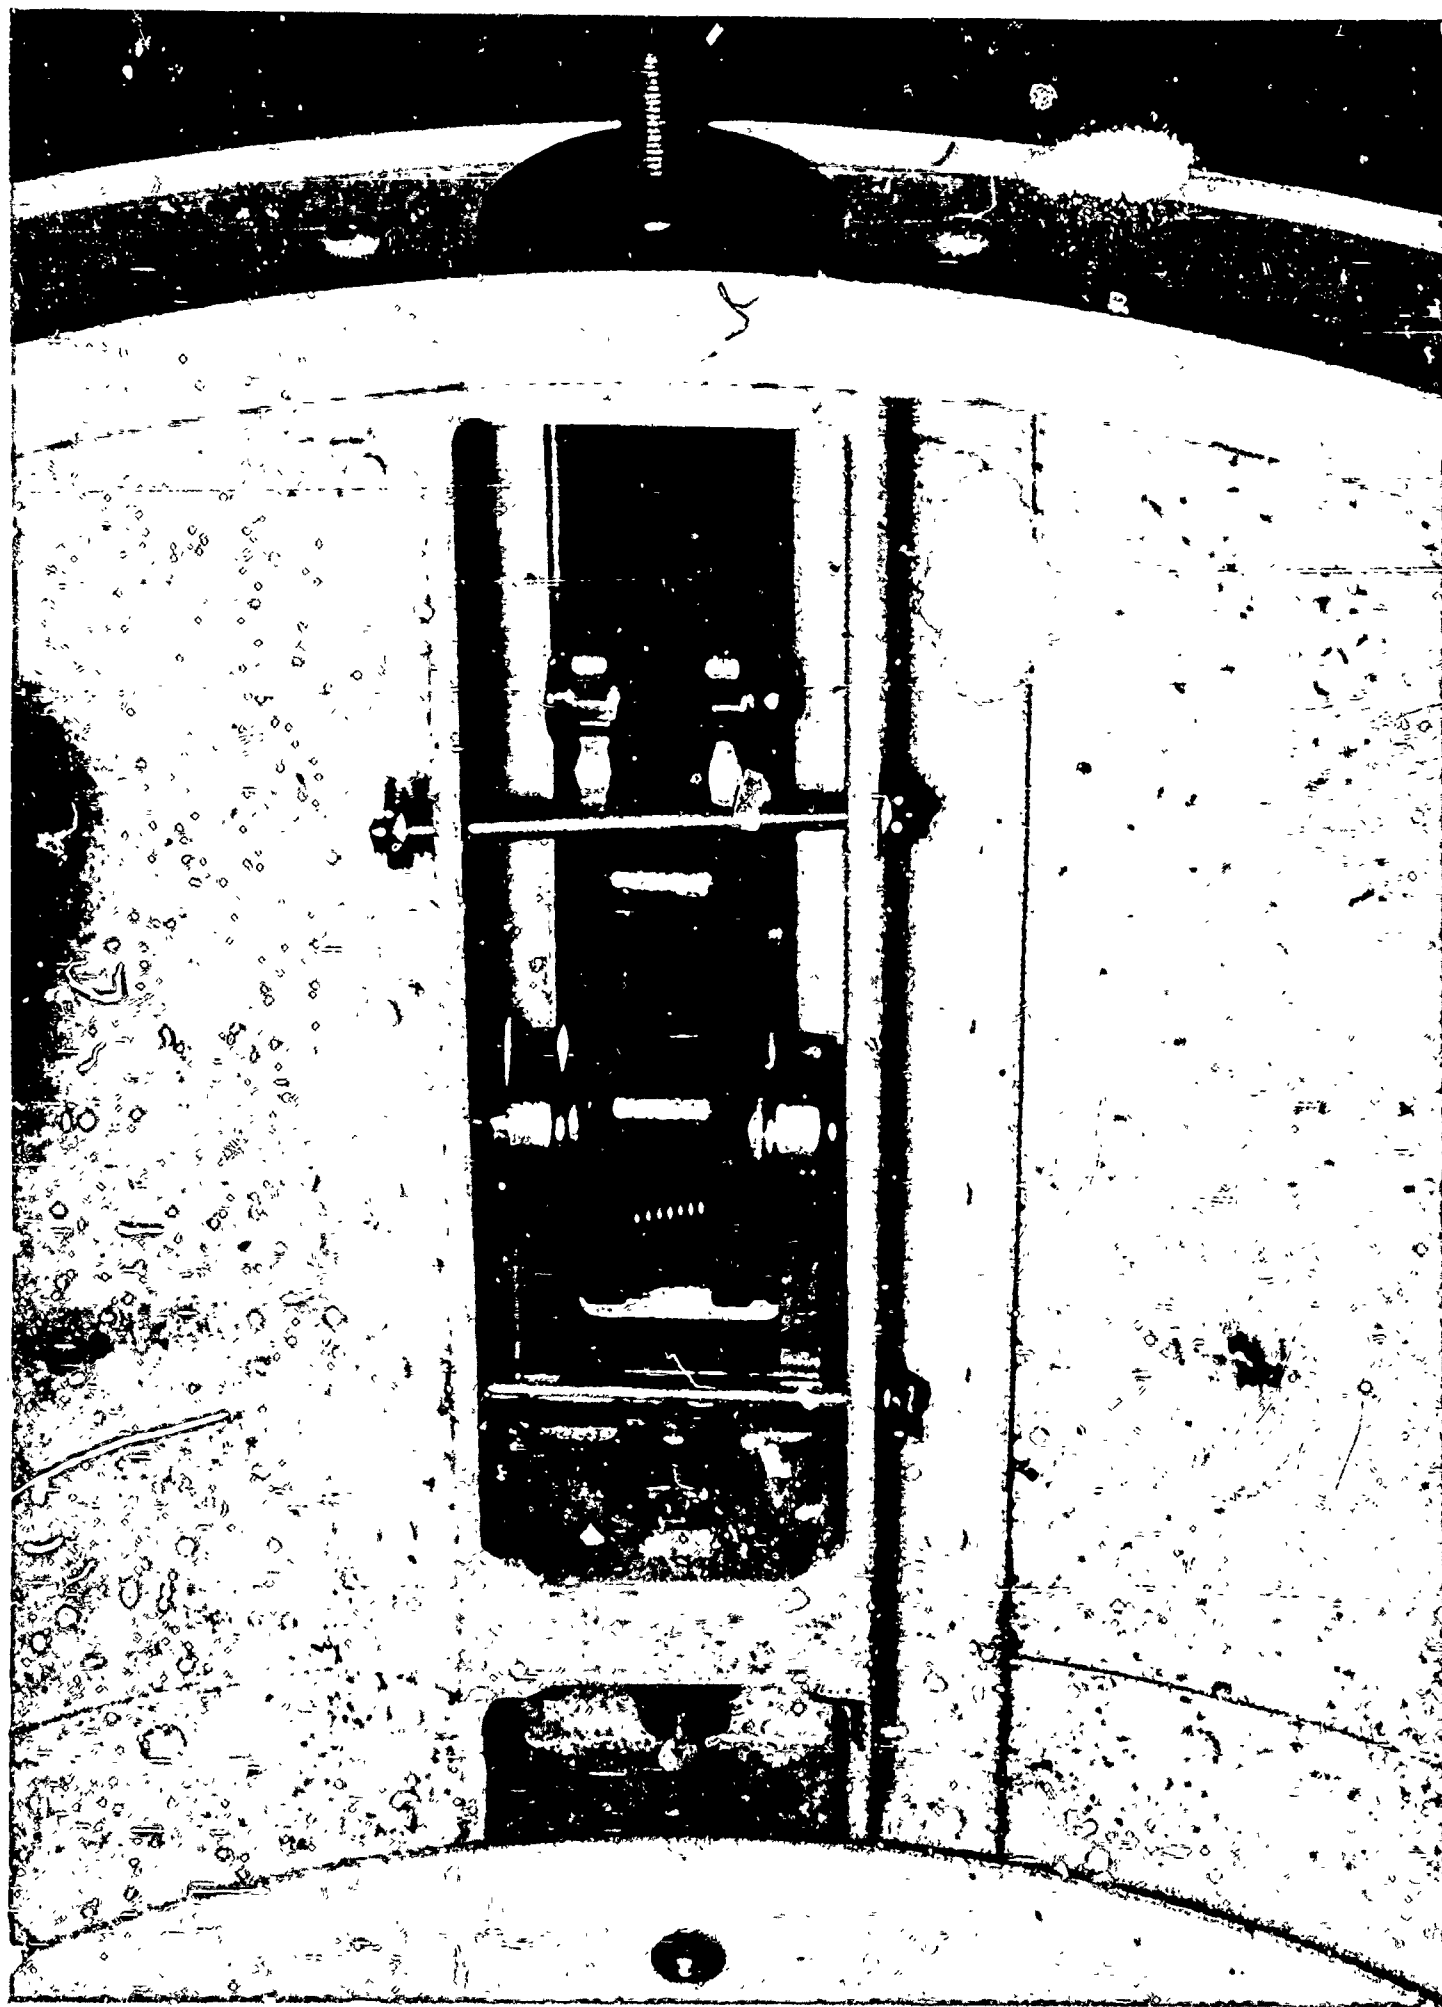
Figure 16. 10,000 lb. Nose Latches

latch. This latch did not have the desired safety factor, however, and a 10,000 lb. latch was installed. There have been no latch failures with the 10,000 lb. latch installation. The blast suppressor was cast of 17-4PH corrosion resistant steel. The nose changes are shown in Figures 15, 16, 17, and 18.

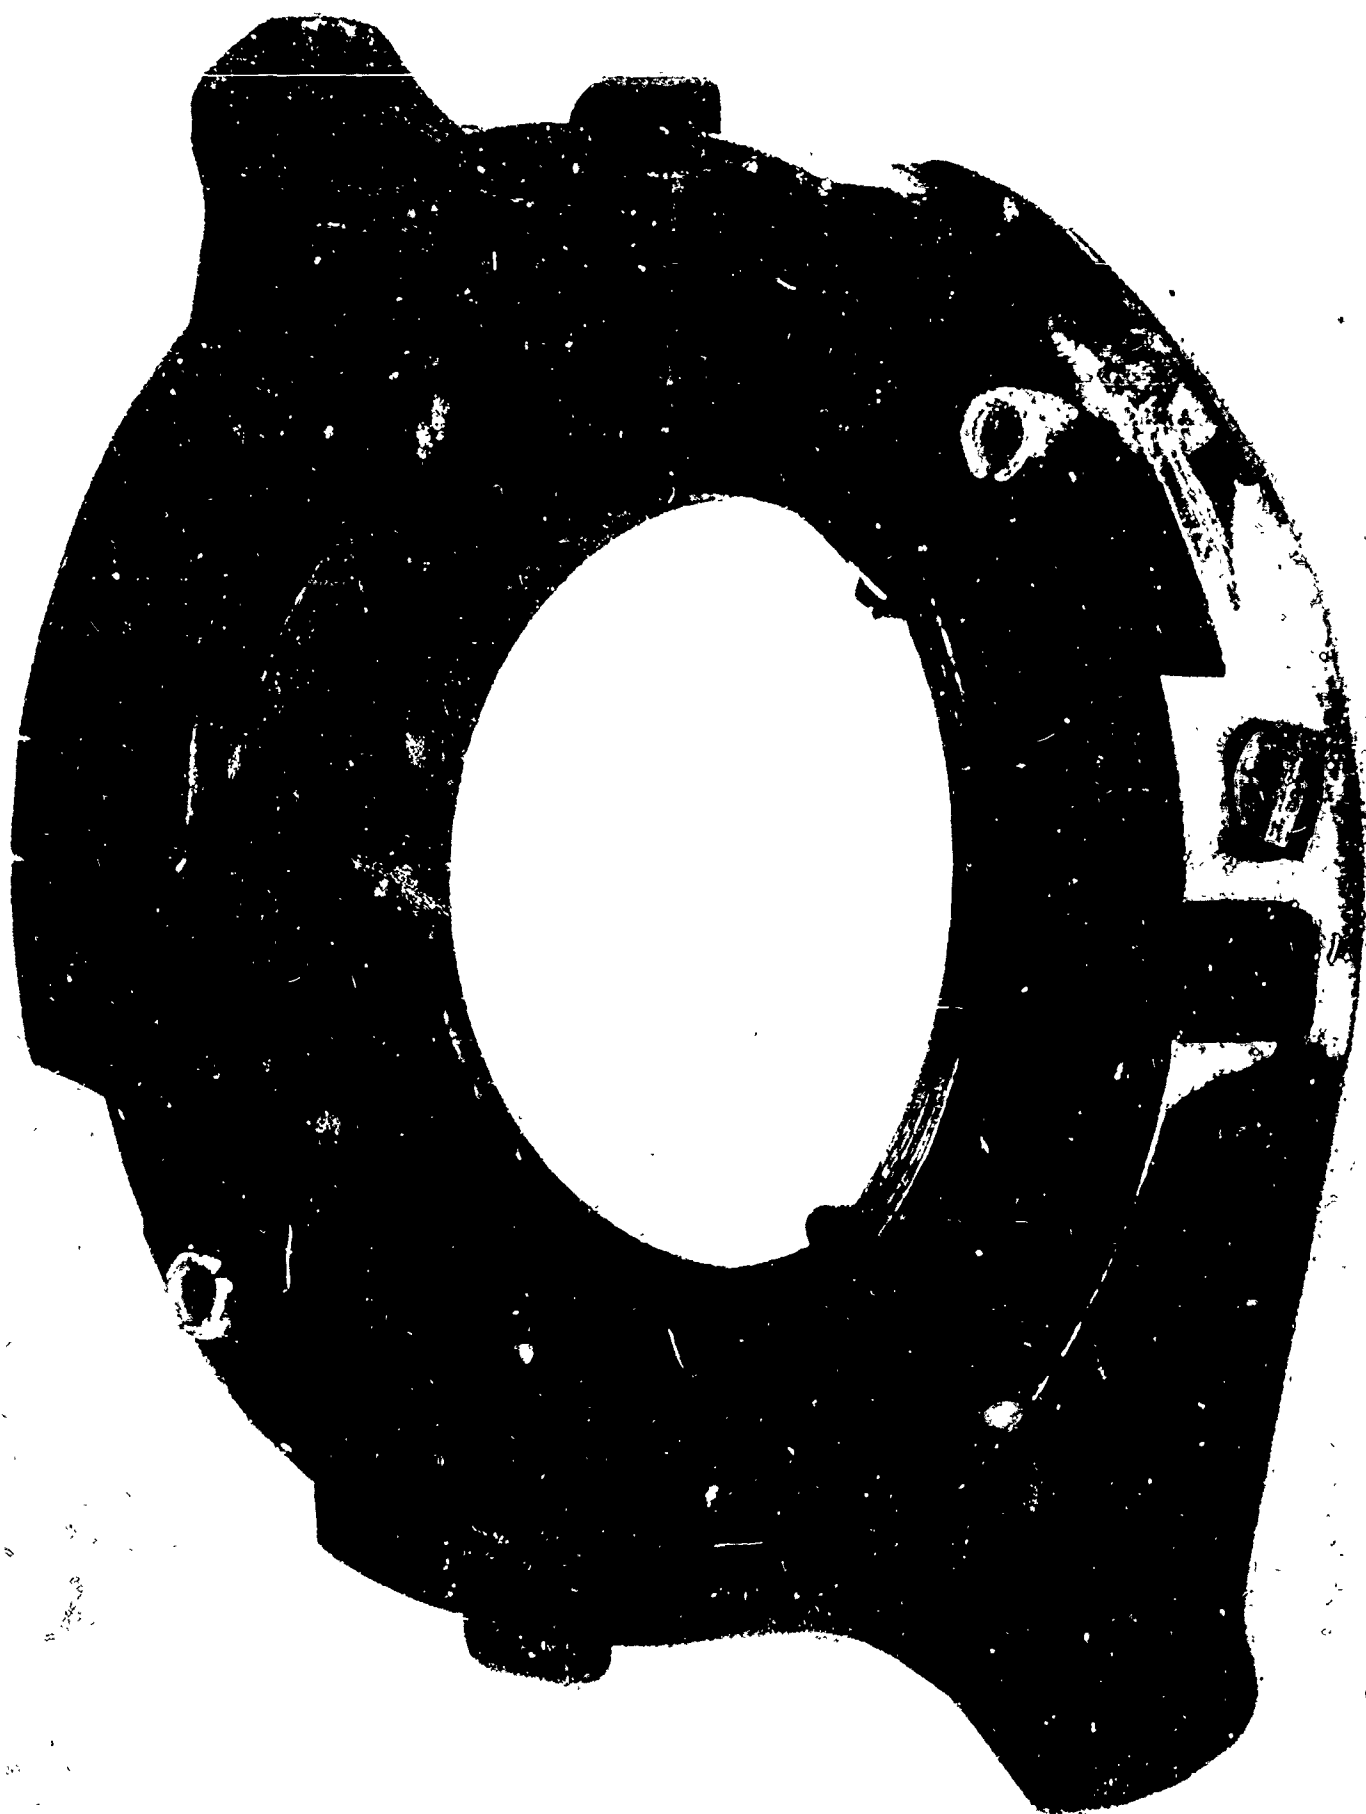
Figure 25. Round Positioner Assembly

The gun junction box housing was changed from a welded-up structure to an aluminum casting as shown in Figure 24. A stiffer ring spring round positioner was added to the Mk 11 Mod 5 Gun, and this increased the force on the latches and detents to 50 lbs. in order to eliminate pre-ejection. Figure 25 shows the new ring spring round positioner.

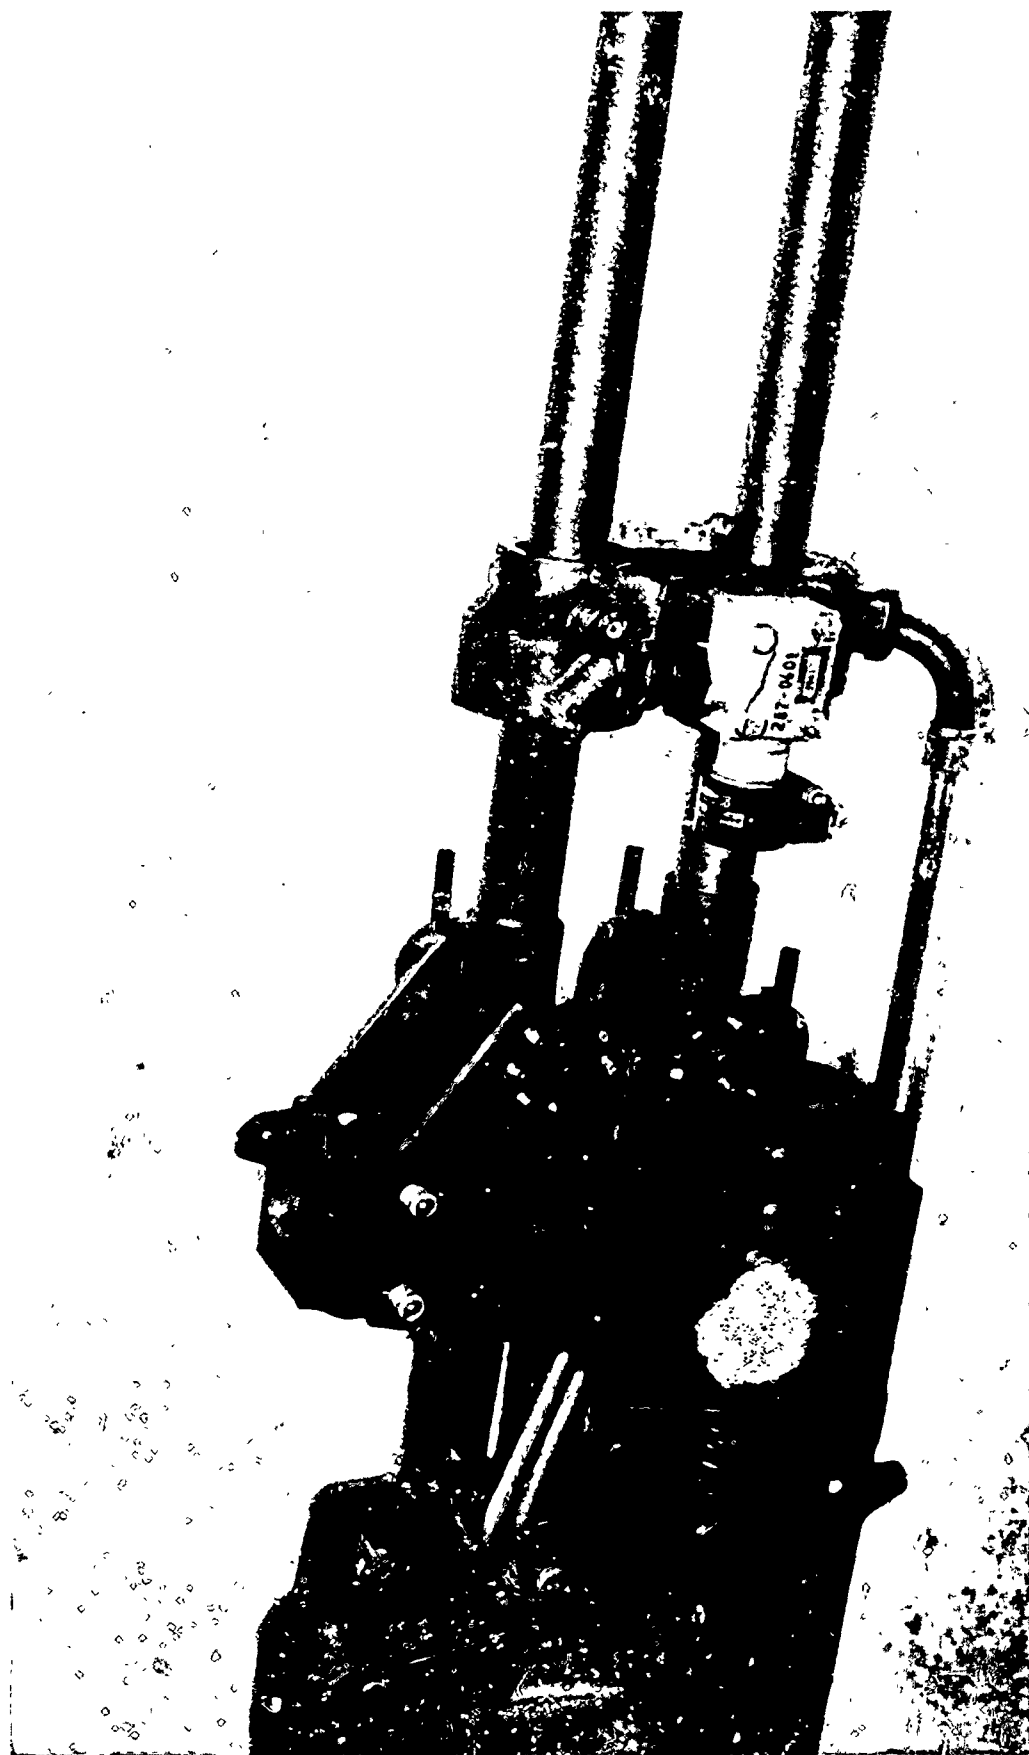
Figure 34. Booster Decoupled from Receiver

An experimental quick disconnect booster block was built in October, and approximately 13,000 rounds have been fired with this part with good results. The booster block attaches to the receiver with four quick disconnects. By rotating the quick disconnects 180 degrees, the booster is locked in place. The booster block also locks the barrels in place by preventing barrel rotation. To remove the barrels the booster block is removed from the gun and the barrels are then rotated to decouple them from the interrupted threads in the breech. Figure 34 shows the booster block decoupled from the receiver. In the final design of the booster housing, it is anticipated using three quick disconnects instead of four in

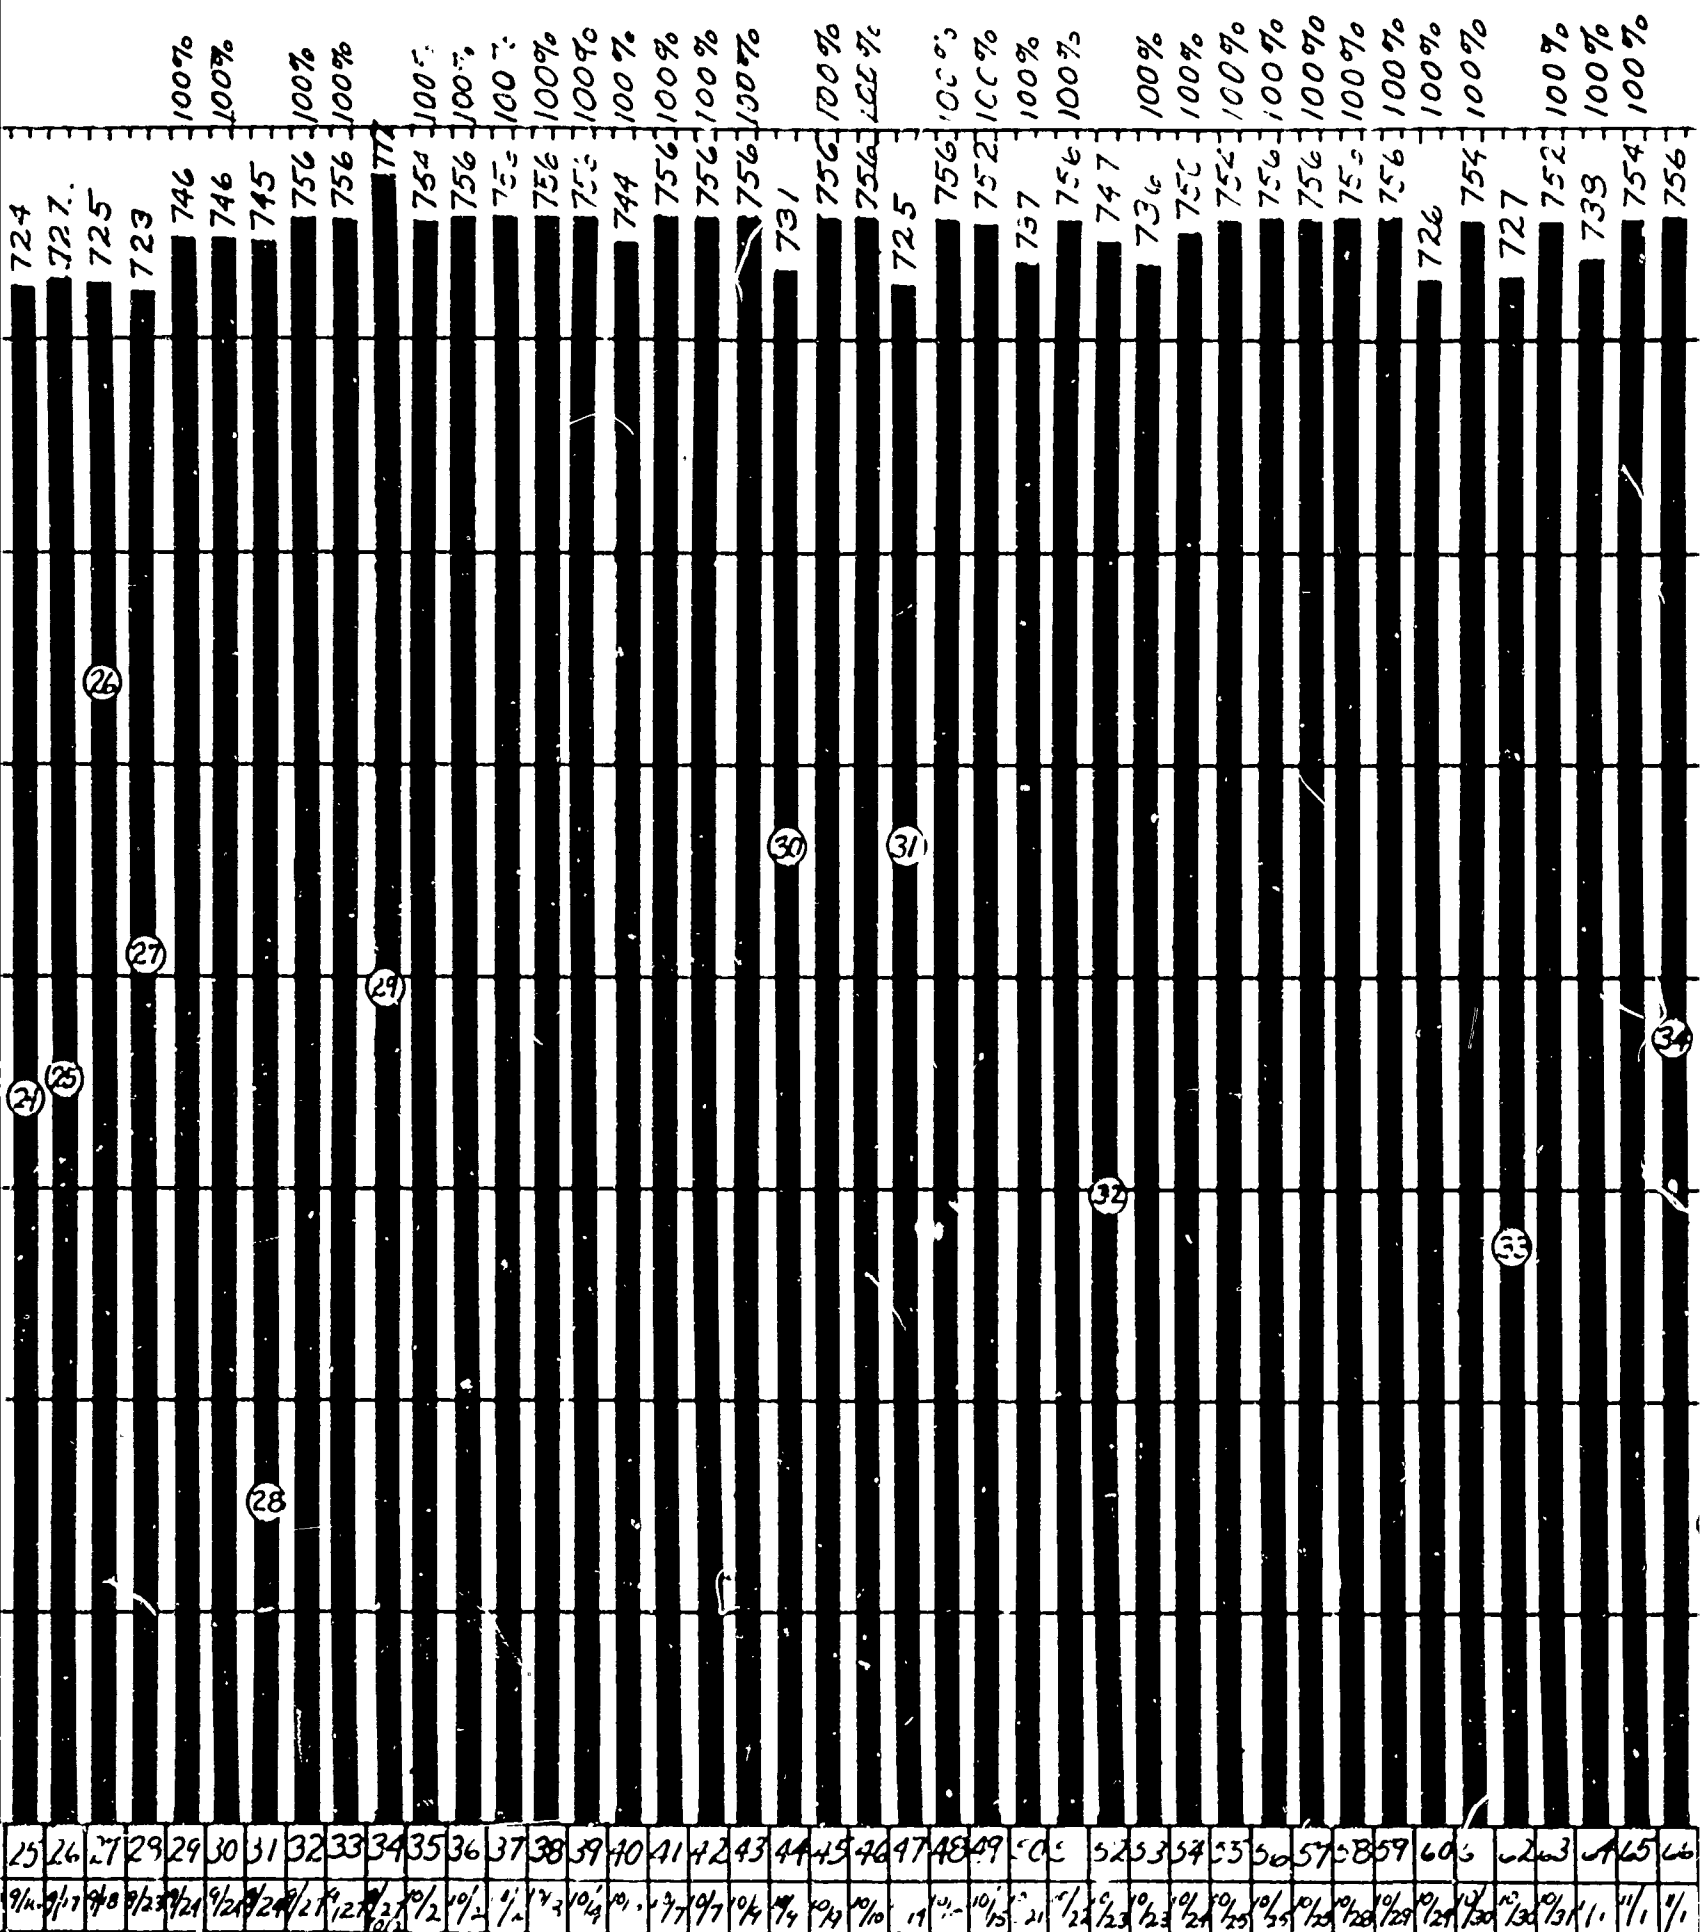
GREEN POD S/N 12

POD RELIABILITY IMPROVEMENT TEST FIRED AND STOPPAGES FOR EACH PODFULL

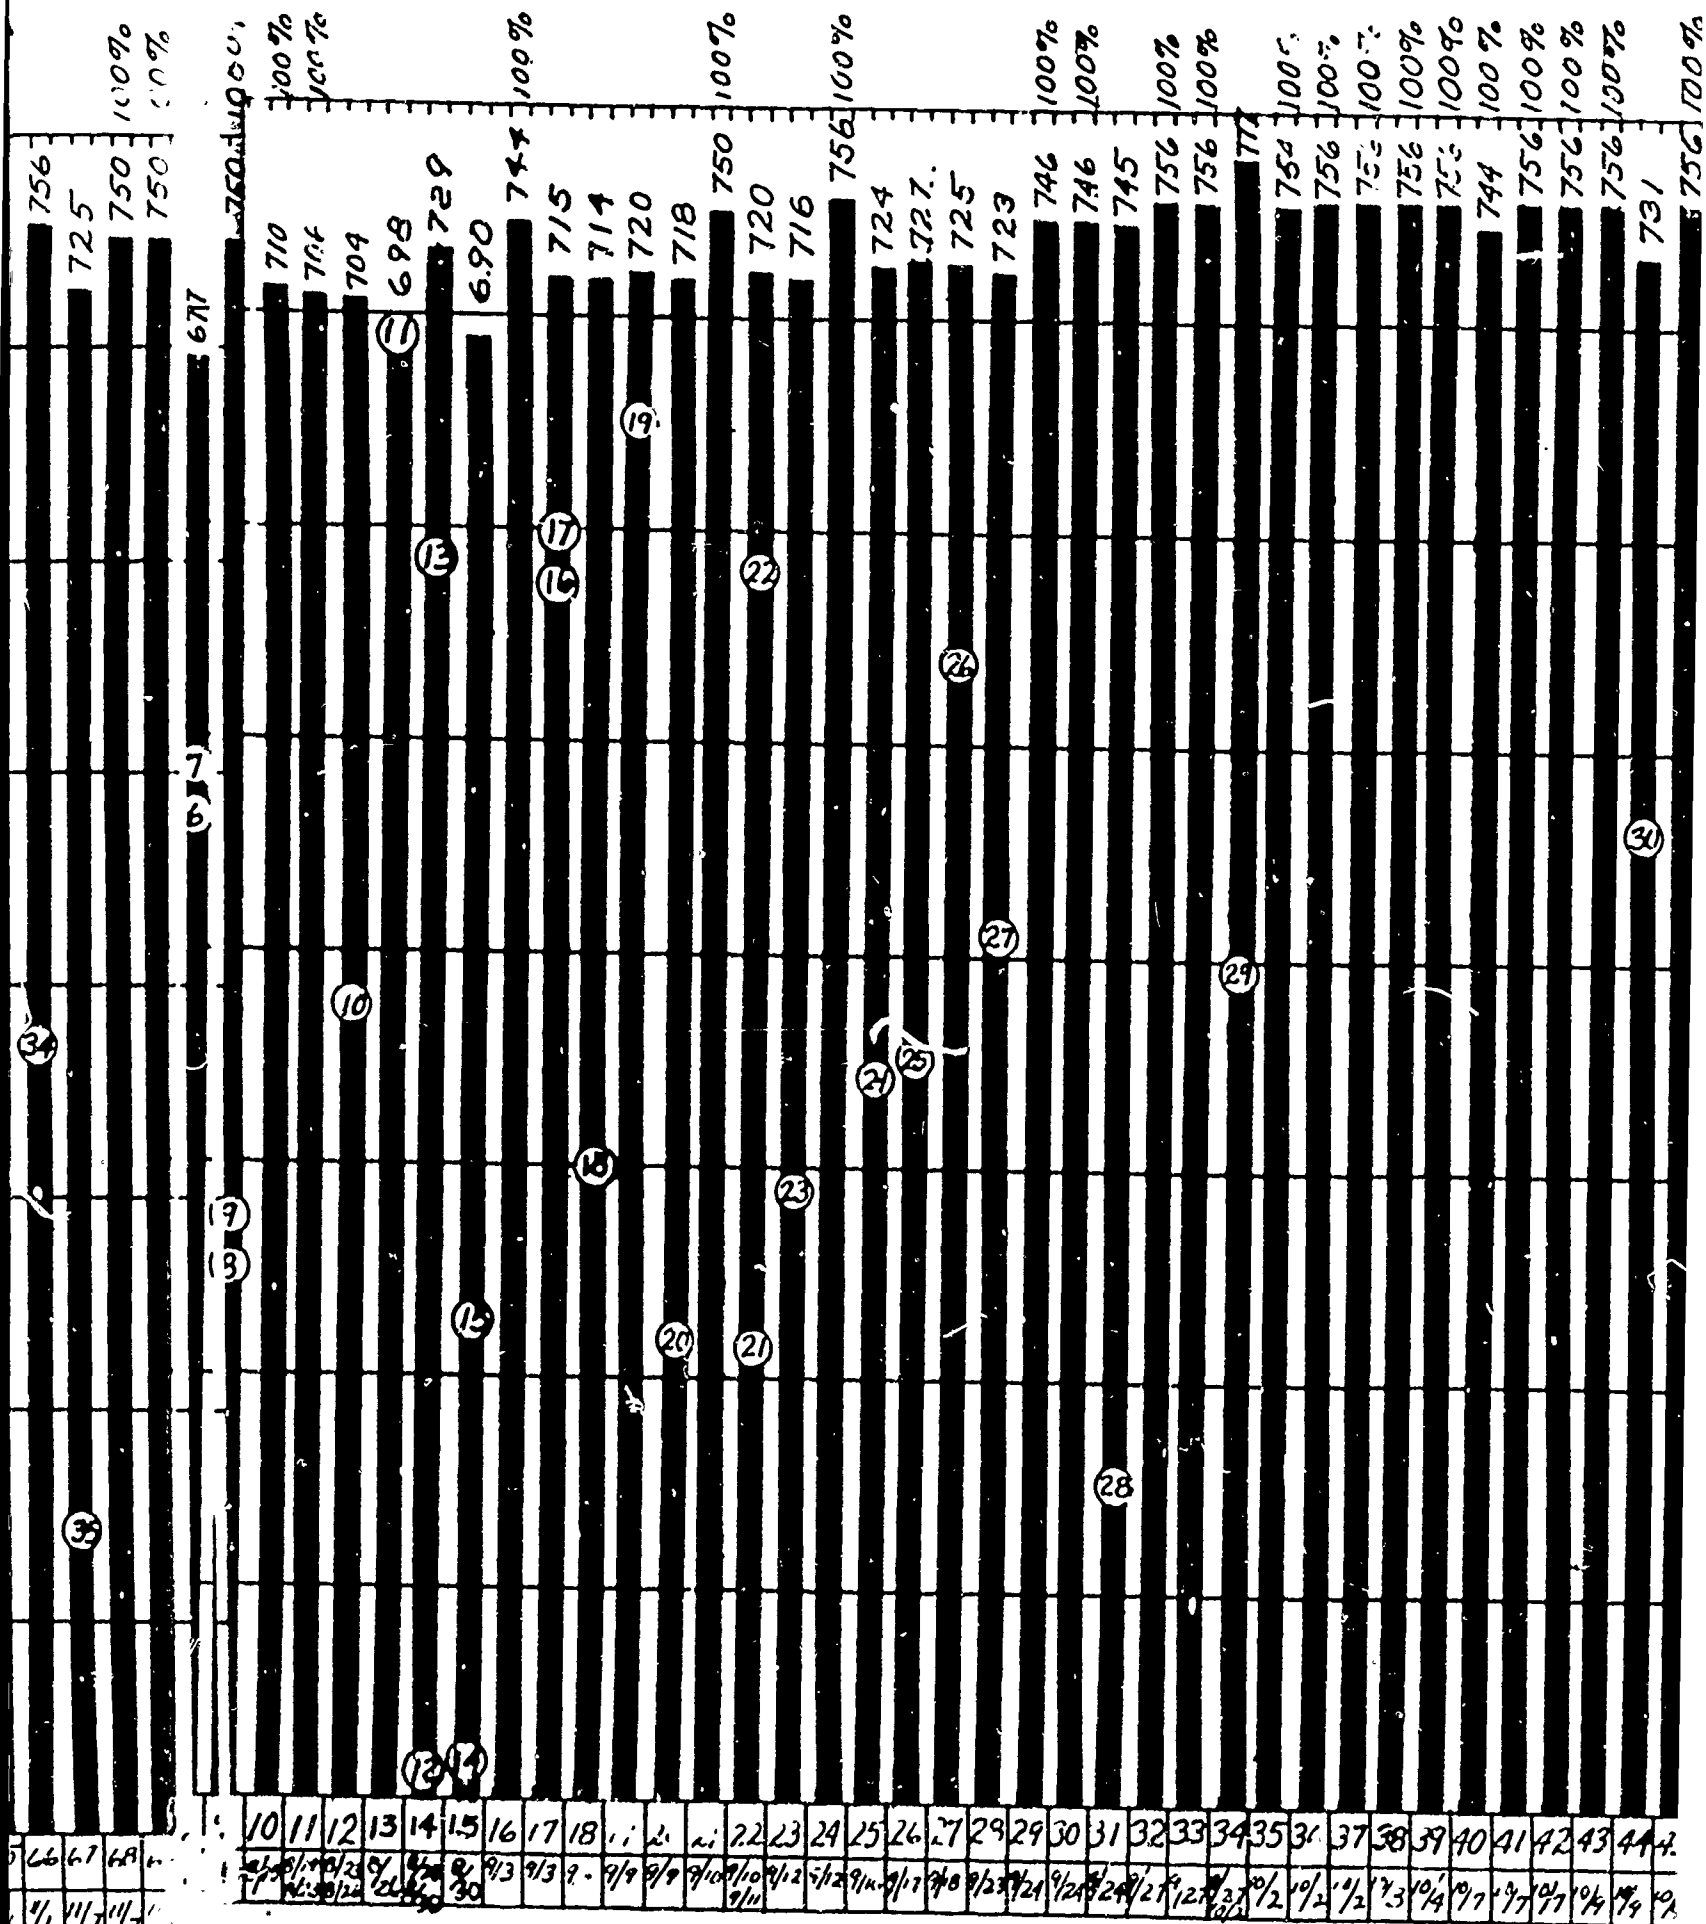
GREEN POD S/N 12

GUN POD RELIABILITY IMPROVE ROUNDS FIRED AND STOPPAGES FOR E
